STABILIZATION OF LOWRY RUINS

ADRIAN S. WHITE
AND
DAVID A. BRETERNITZ

Mesa Verde Research Center
University of Colorado
Boulder, Colorado

March 1976

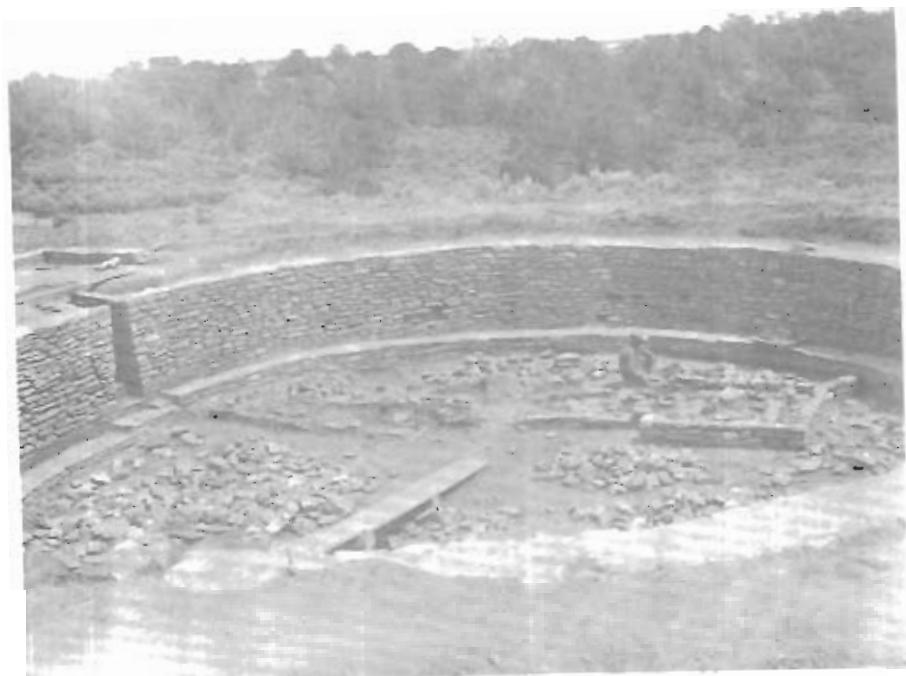
The second season began in June, 1967. The Pueblo was completed and work began on the Great Kiva. The major reconstruction necessary to restore the Great Kiva is seen in Figure 8. Surface runoff down the walls and recessed stairway had caused rapid deterioration.

Figure 8. Great Kiva, 1967. a, southeast view before stabilization; b, east view during stabilization.

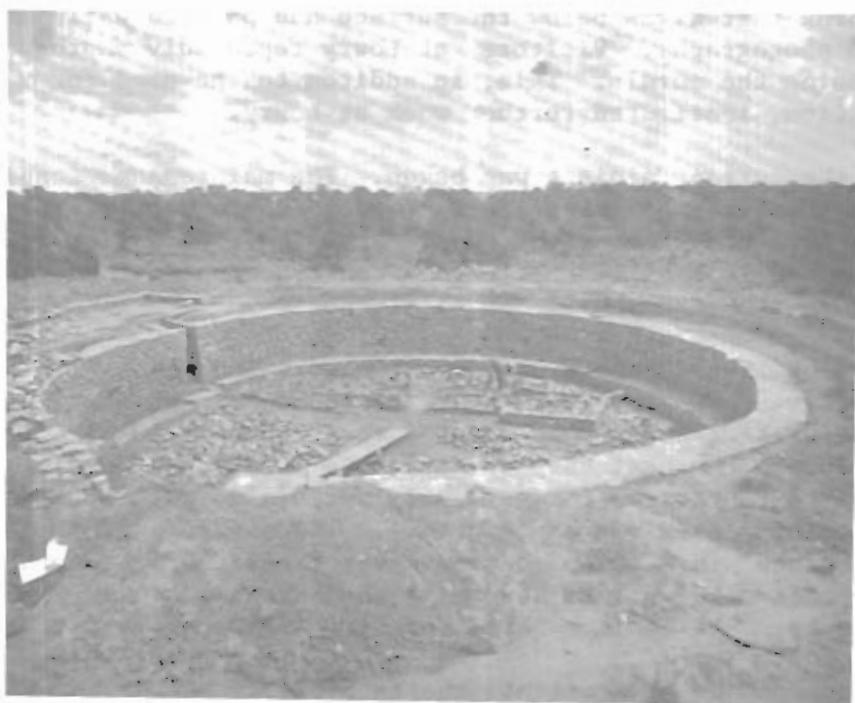
Figure 9. Great Kiva, 1967. a, room block to north during stabilization; b, walls were stabilized higher to the inside to drain water outward away from walls.

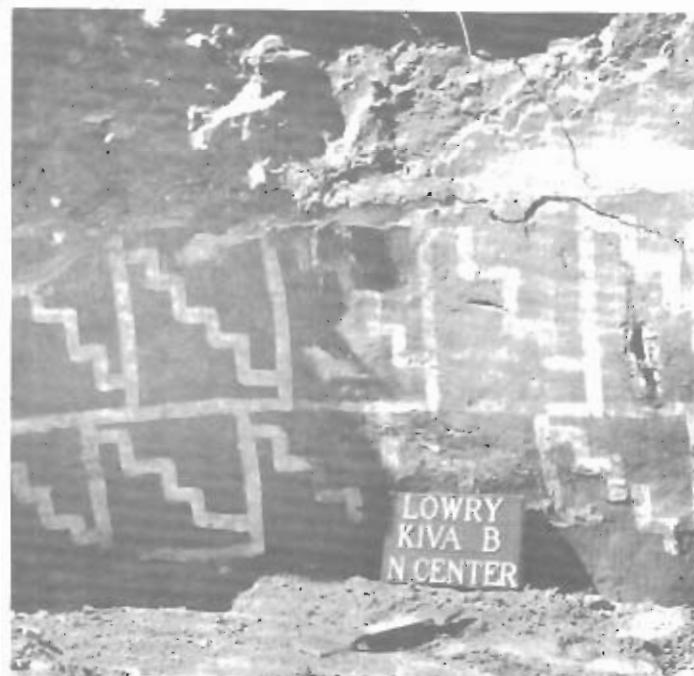
With the excavation of Kiva B the walls of Kiva A were almost completely removed, with only a small area remaining on the west side. Kiva B was excavated to 5-10cm above the floor. The benches were cleaned and the murals were photographed (Fig. 14). The condition of the murals was excellent in the areas that had not previously been excavated. Those areas that were lacquered showed damage primarily between the first and second pilasters. Painting the murals with shellac created a hard frontal surface which caused the plaster to separate from the stone wall and other layers of plaster. The presence of moisture, dirt, and roots behind these separated areas increased deterioration. When these areas were excavated, the plaster either crumbled or gradually began to break down as it dried out; no successful process has been discovered to stop this type of deterioration.

Figure 14. Kiva B. a, north view of murals after excavation in 1974; b, close-up of damaged area where plaster is peeling from the walls.

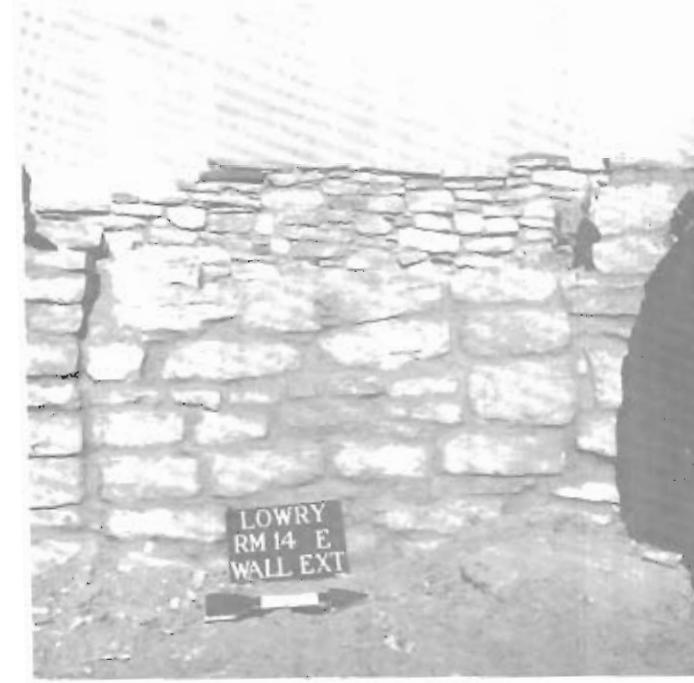
- A. The east exterior wall of Room 14 is capped on the upper 2 courses. The lower courses are composed of prehistoric masonry. Stones beneath the capped area are loose and the soil mortar is falling out and flaking off.
- B. No prehistoric masonry remains in the arch of patch on the south wall of Rm. 18.

Figure 35. Room 14, east exterior wall. a, several stones were missing and large joints were created by crumbling mortar; wall was slumping at the abutment to Room 12; b, missing stones were replaced and the wall was straightened.

- A. East Ext. wall of Room 14 - all loose stones were removed and reset with a mixture of Portland cement and sand. The area reset was approx. 4-5 courses in height. Area was pointed with a soil mortar of 3 parts soil to 1 part sand.
- B. South Int. wall of Room 18 - several stones were reset with a mixture of Portland cement and sand.

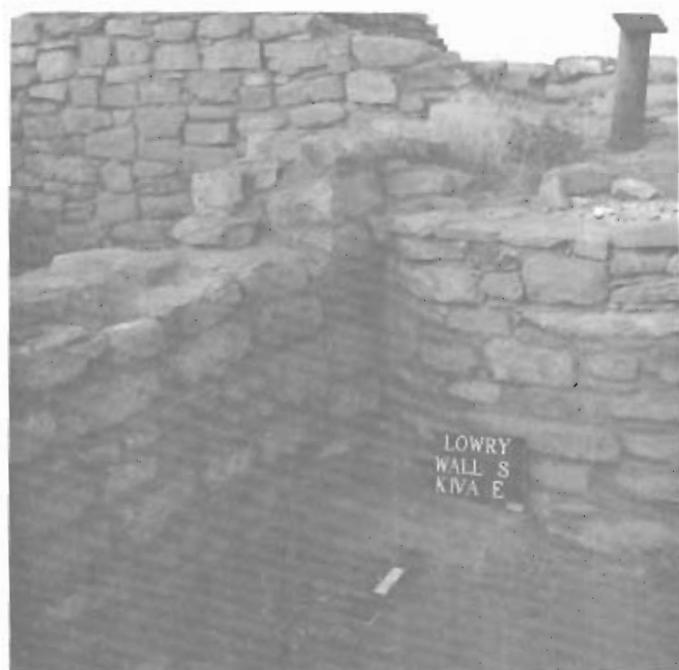
- A. Building stones had fallen in central area of wall from the 3rd to 8th courses. Soil mortar was in a crumbling state with stones loosened and several missing. Large joints were created by missing joints.
B. No prehistoric masonry remained, entire SE corner of this wall was set in cement in 1966.

Figure 36. Kiva E, south exterior wall. A, several stones were missing and large joints were created by crumbling mortar; b, stones were reset and all large joints were filled.

- A. All loosened stones were removed along with all loose soil mortar. Stones were reset with a mixture of Portland Type I and II cement and Shiprock sand. All newly cemented joints were pointed with soil mortar of 2 parts soil to 1 part sand.
B. Loosened stones were removed and reset with mixture of Portland cement and Shiprock sand. Area was pointed with soil mortar of 2 parts soil to 1 part sand.

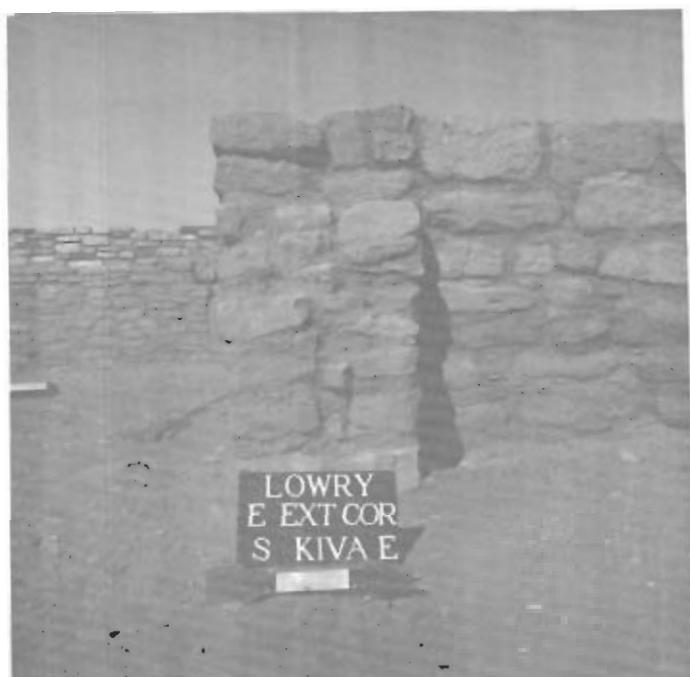
Figure 37. Kiva E, east exterior corner south of Kiva E.
View after corner was stabilized. Several stones were reset
and pointed with mortar.

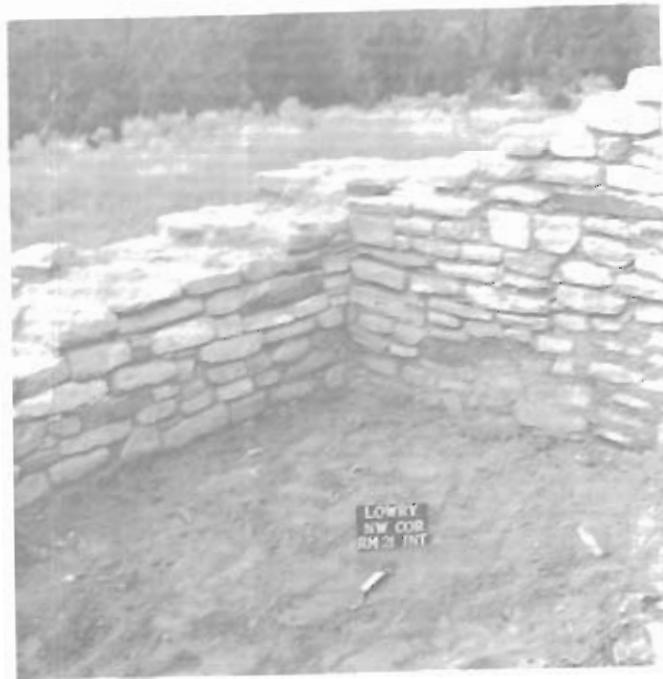
Figure 38. Room 21, northwest interior corner. a, large area of missing and fallen stones caused by undermining; b, stones were reset and pointed with soil mortar, soil was banked against the wall and sloped towards the center of the room.

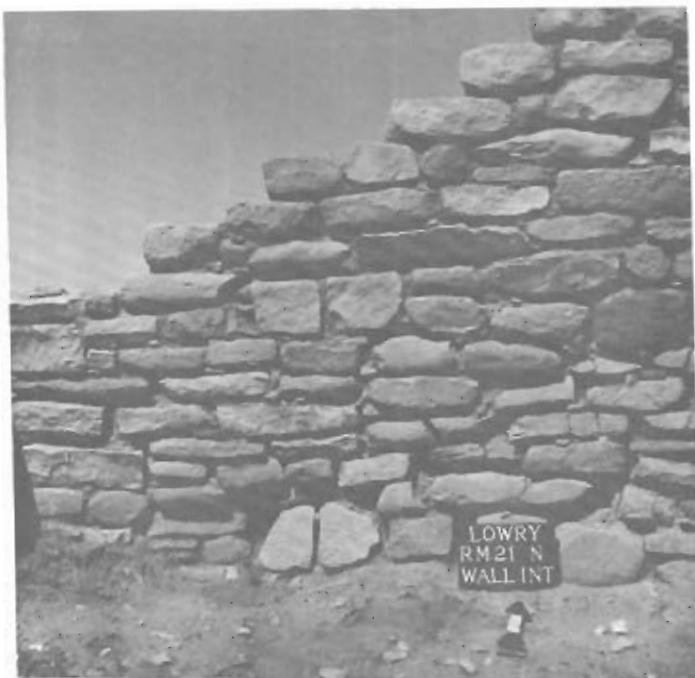
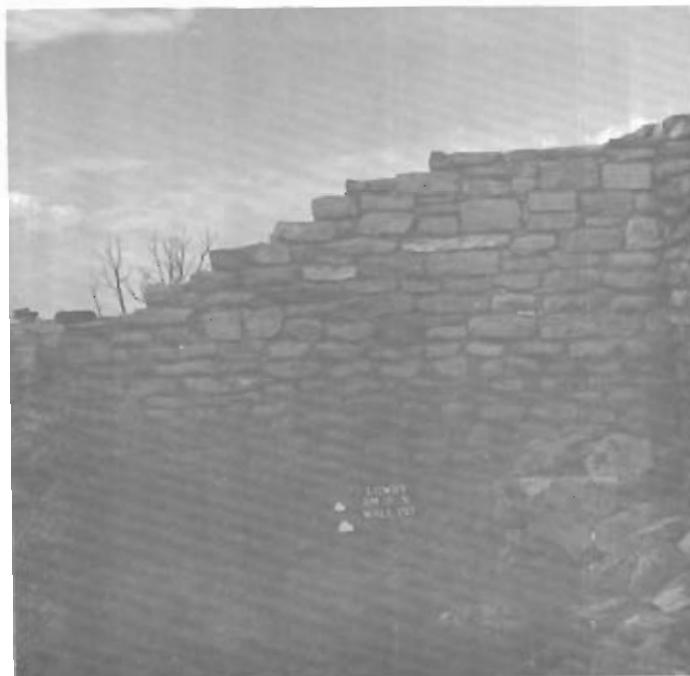
Figure 38. Room 21, north interior wall. c, damage included fallen stones and large joints; d, all loose stones were reset and large joints were pointed with soil mortar.

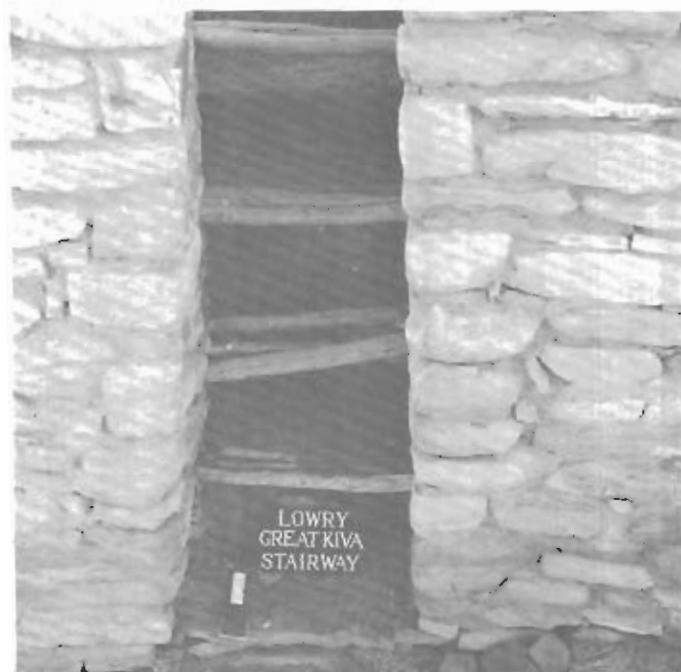
Figure 40. Great Kiva, stairway. a, stairway before stabilization in 1966; b, water runoff down stairway caused erosion behind wooden post steps.

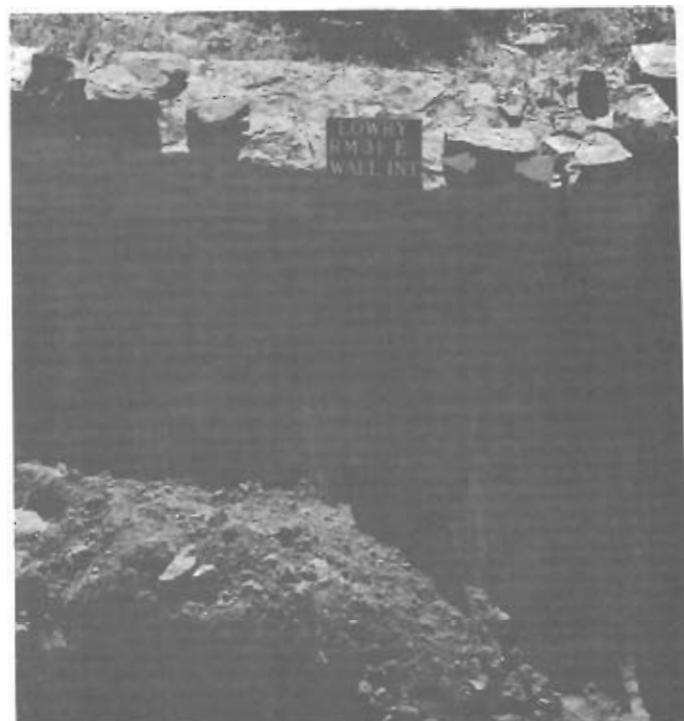
A trench was first dug in front of interior east wall of room 31 to locate the extent of undermining to the wall. A gap of 2-3 courses was observed below surface level of room. The length of erosion was from NE corner to 1 meter from SE corner. Old building stones were reused in ured areas with a mixture of Portland Type I and II cement and Shiprock sand. Area was pointed with a soil mortar mixture of three parts sand to 1 part sand.

Figure 47. Room 31, east interior wall. Wall was undermined 2-3 courses beneath upper 2 course cement cap. No photo was taken before stabilization.

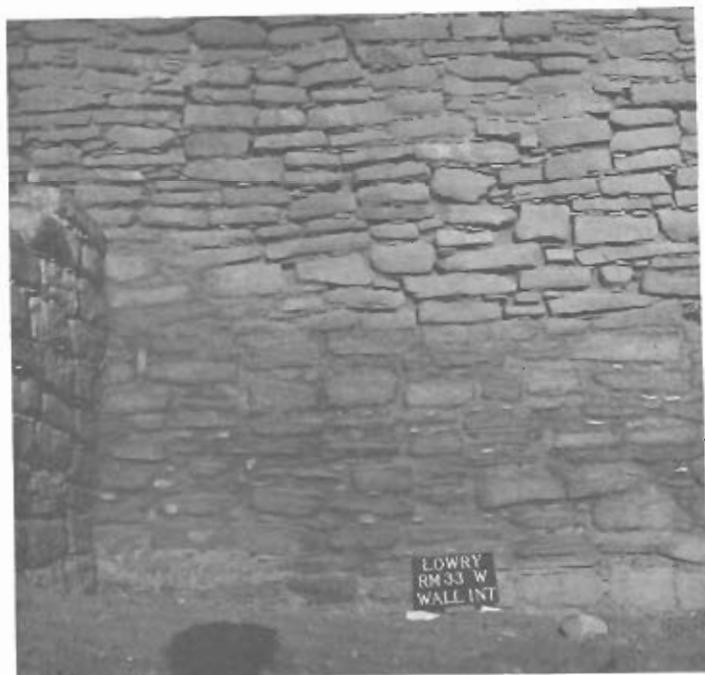
Figure 49. Room 33, north end of west interior wall. a, damage was confined to mortar crumbling from joints; excavation below ground surface showed no undermining of wall; b, soil mortar and spalls were replaced in the lower portion of the wall.

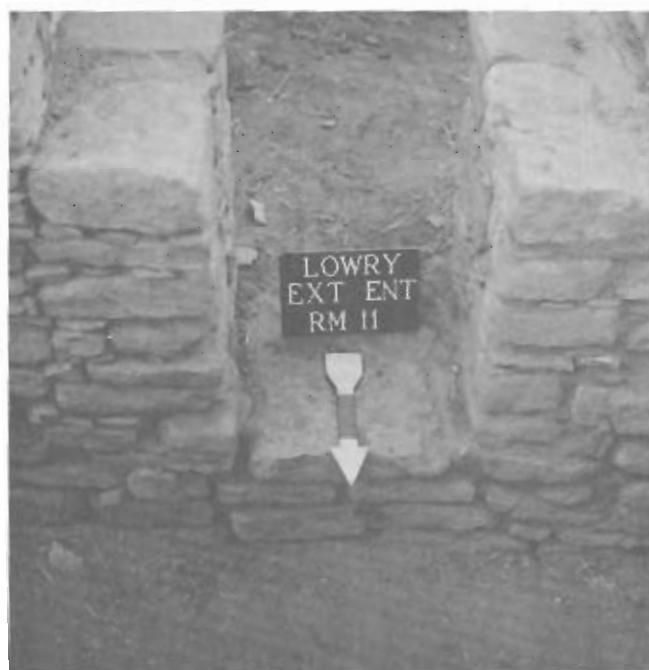
Figure 50. Room 11, north exterior entrance. a, step was loose, a stone was missing from the west side of the entrance and mortar was cracking from the joints; b, after stabilization.

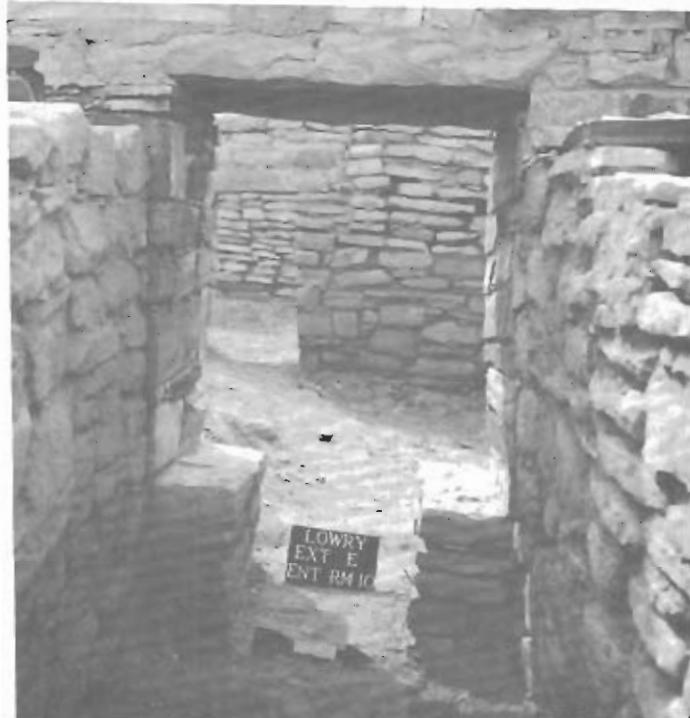
Figure 51. Room 10, exterior entrance. Several stones were replaced on the top course of the south bench of the T-doorway. No photo was taken before stabilization.

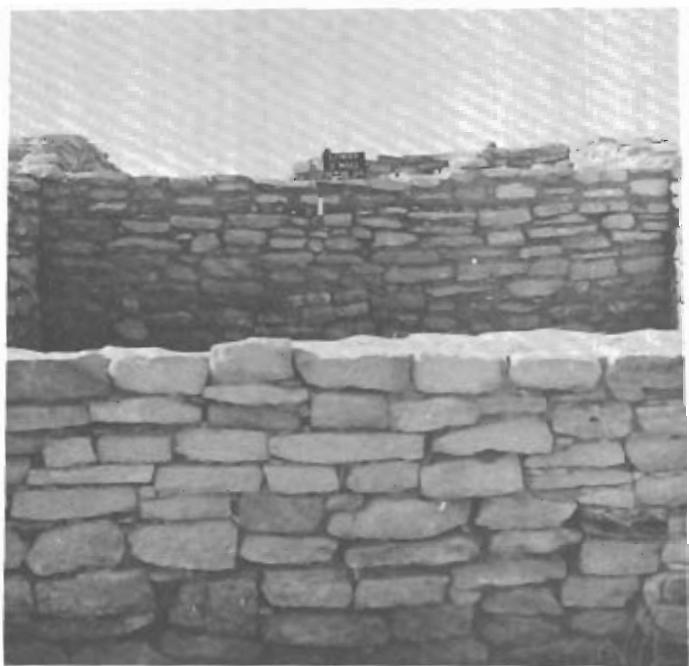
Figure 57. Room 24, south interior wall. Replaced 2-3 courses immediately below the cement cap. No photo was taken before stabilization.

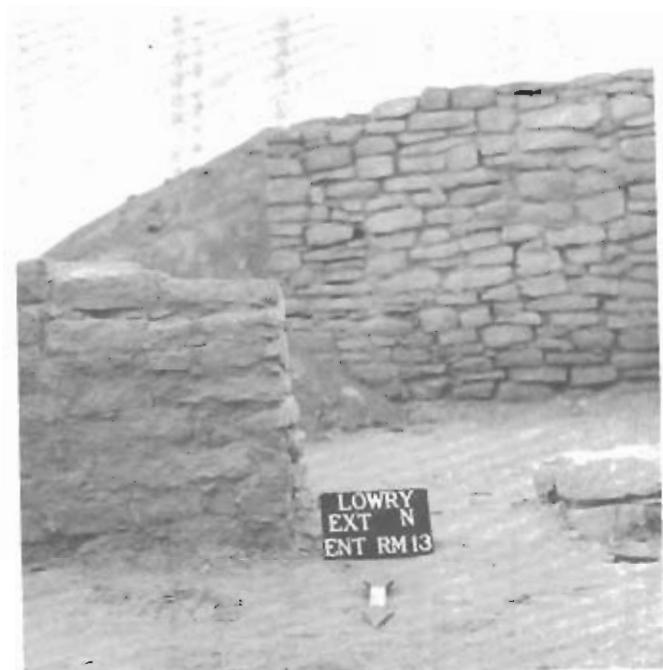
Figure 60. Room 13, north exterior entrance. Several stones were reset on the west side of the entrance. No photo was taken before stabilization.

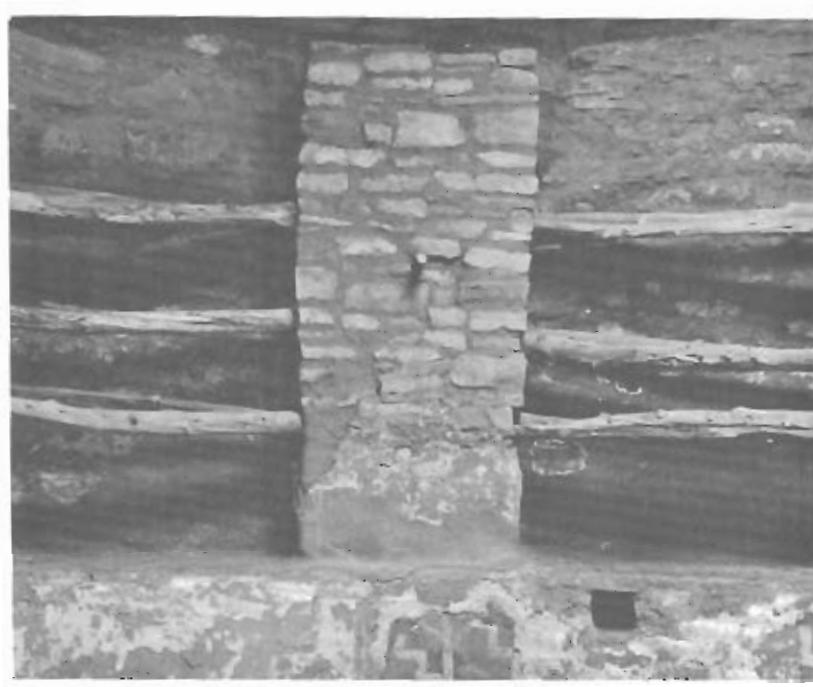
Figure 69. Kiva B, pilaster 2. View after stabilization. No photo was taken before stabilization.

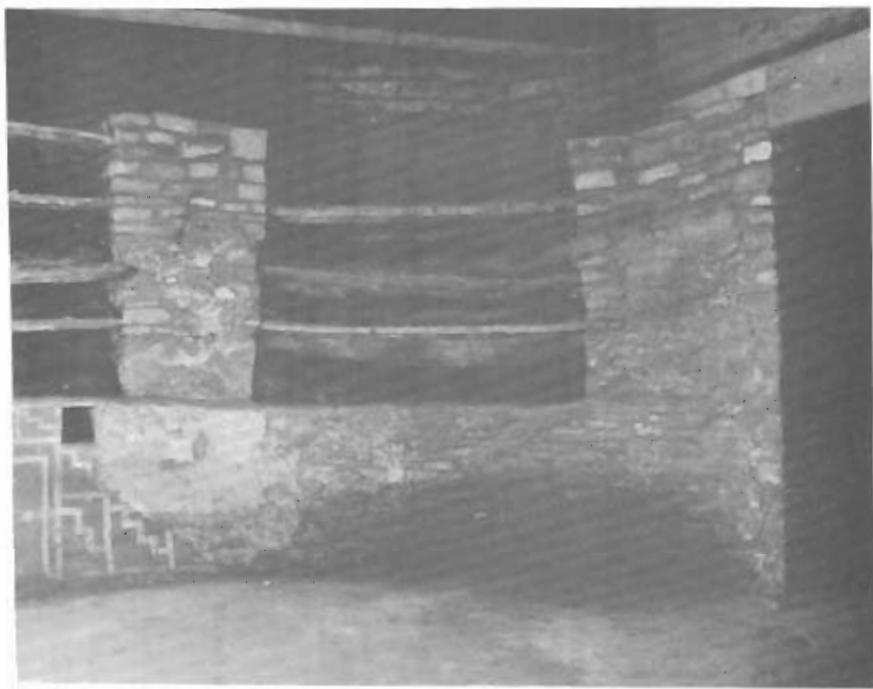
Figure 70. Kiva B, interior walls. Floor near the gate has been resurfaced and all newly cemented joints have been covered with soil mortar.

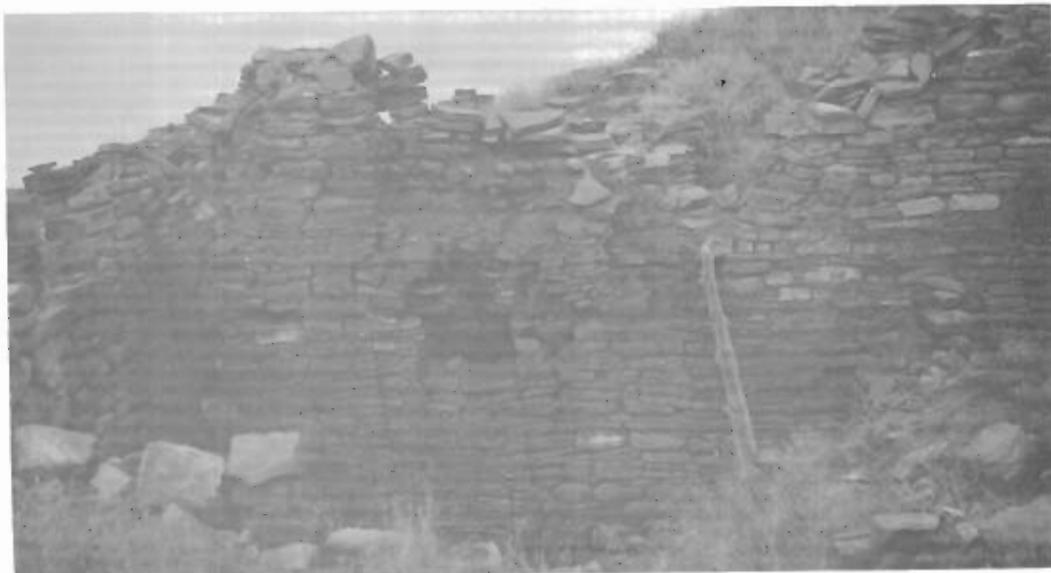
Figure 71. Room 27, east exterior entrance. a, entrance before stabilization in 1965; b, after stabilization in 1965 room was filled to above "T" of doorway.

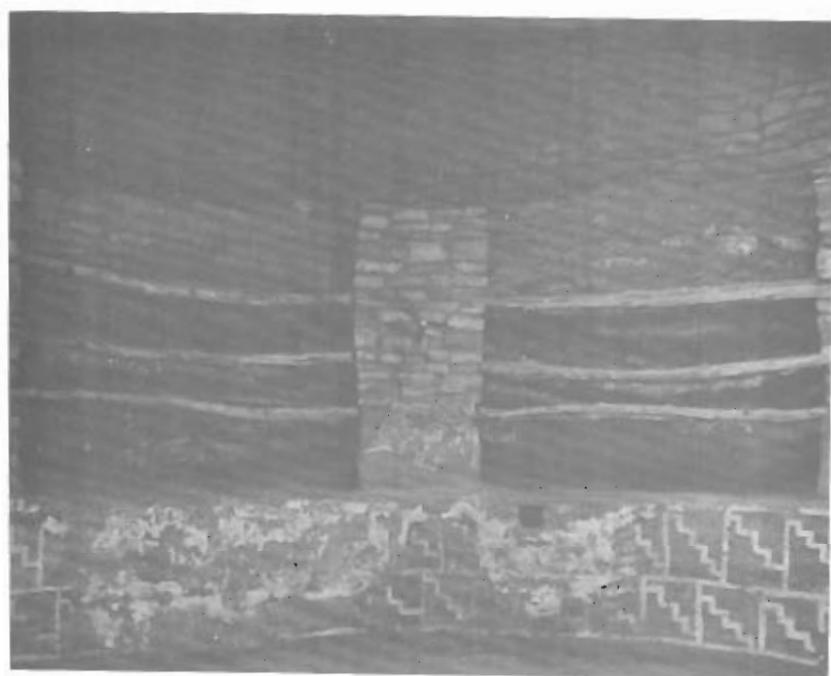
Figure 72. Kiva A, west wall. West view of wall after stabilization as retaining wall and as a foundation for roof.
